CANOPY & DUCT CLEANING SERVICES LTD.

REPORT

**AHU's 1 & 2 SUPPLY & RETURN
DUCTWORK SYSTEMS CLEANING**

AHU's 1&2 supply and return air systems cleaning

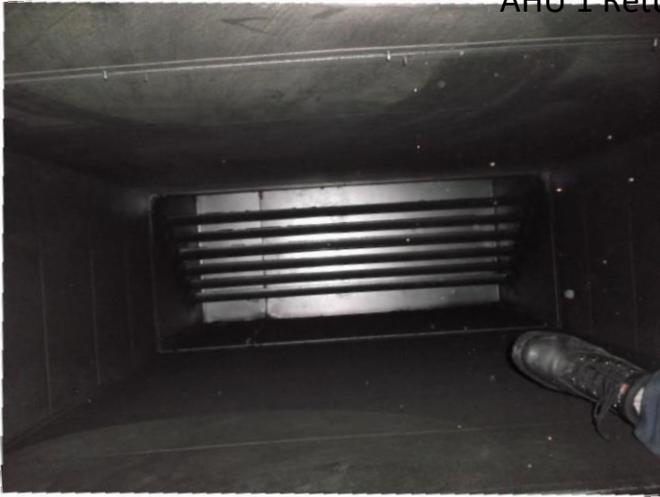
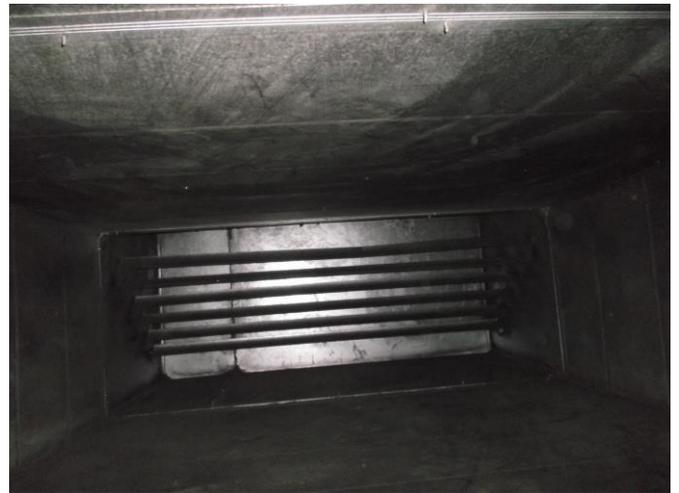
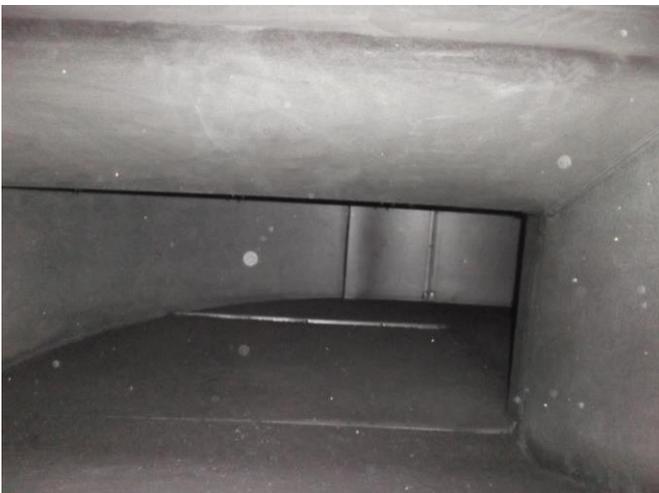
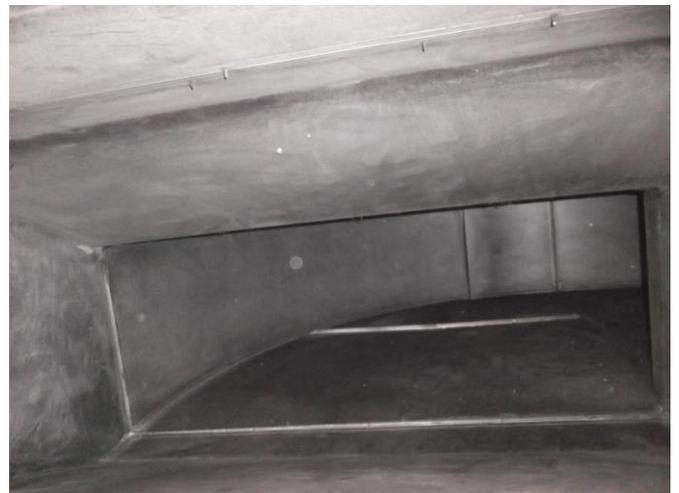
AHU 1 Return air leg 1C2

Before cleaning

After cleaning

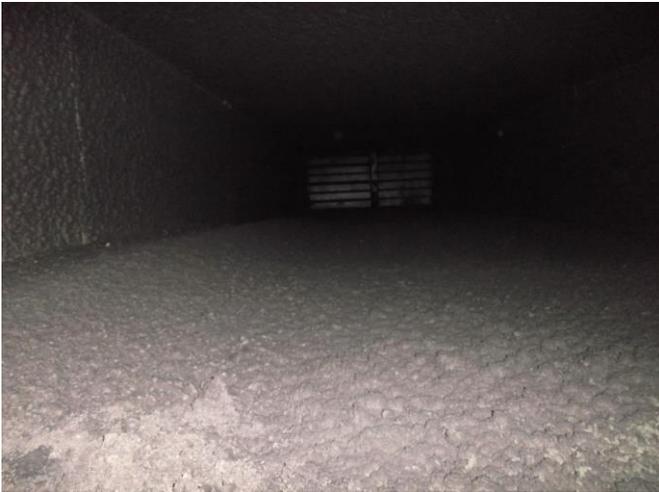
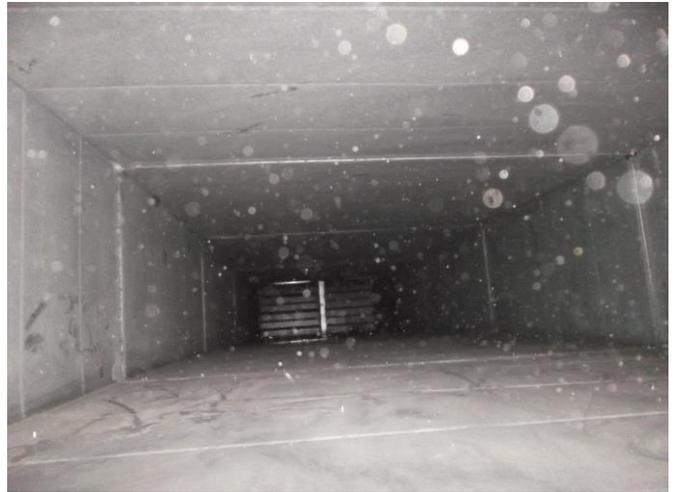
AHU 1 Return air leg 1C4

Before cleaning

After cleaning

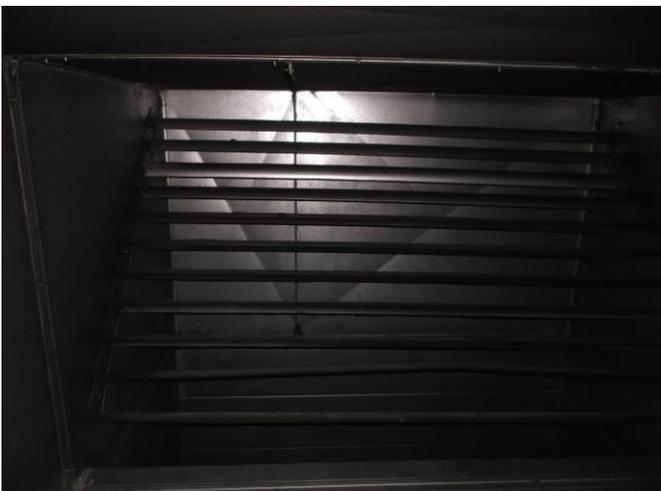
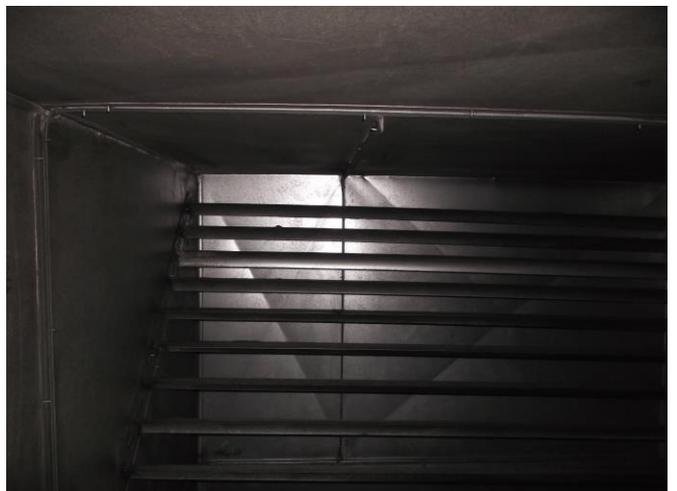
AHU 1 Return air leg 1A2

Before cleaning

After cleaning

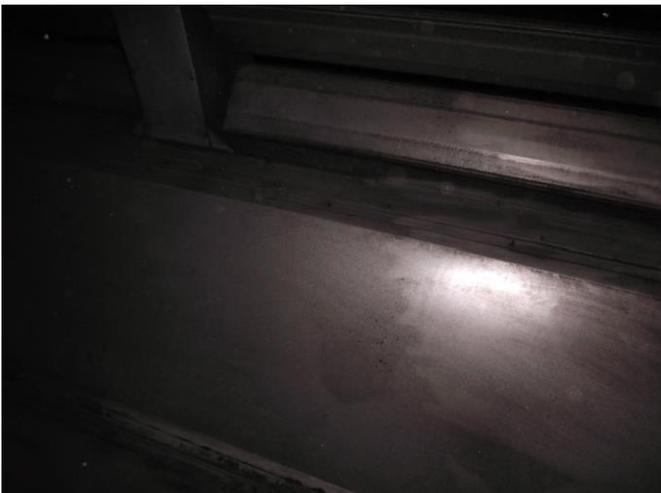
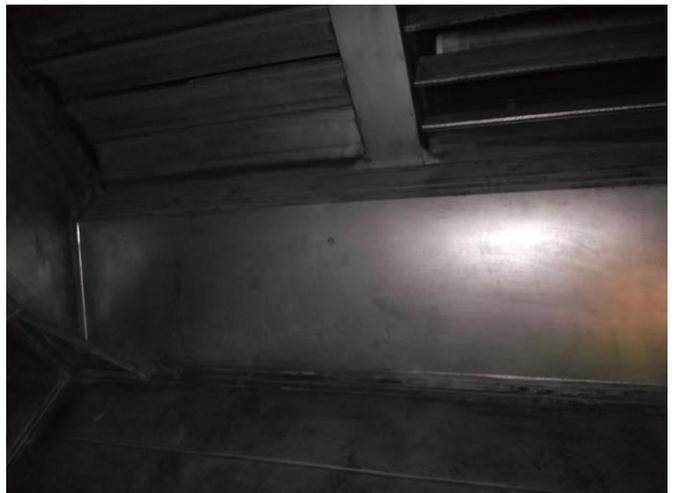
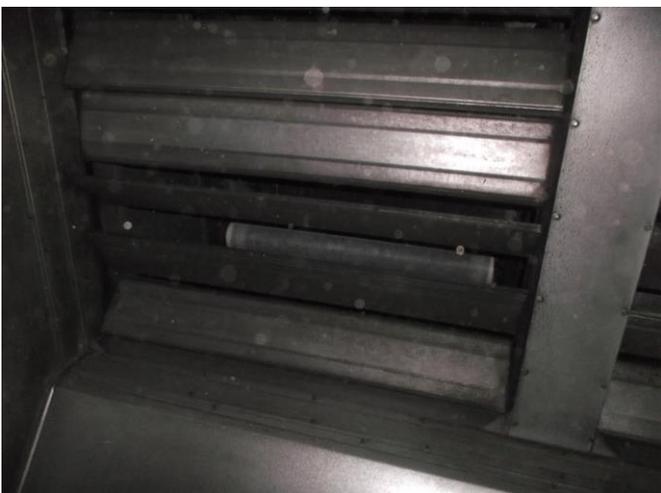
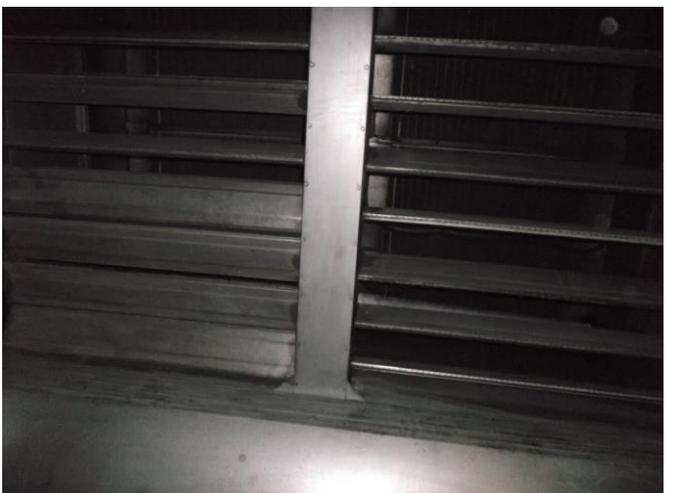
AHU 1 Return air leg 1A

Before cleaning

After cleaning

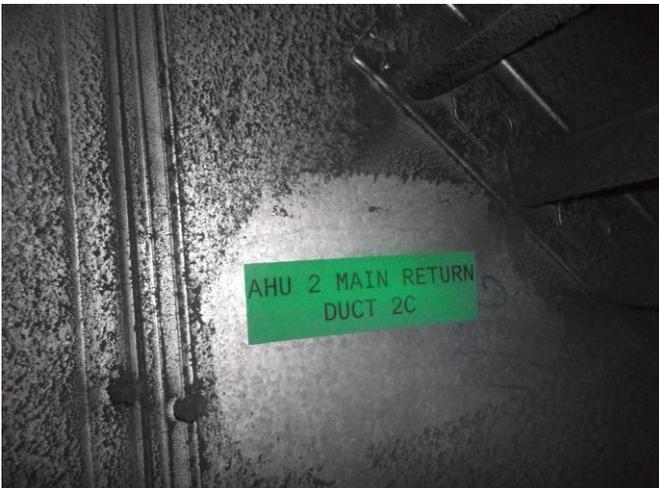
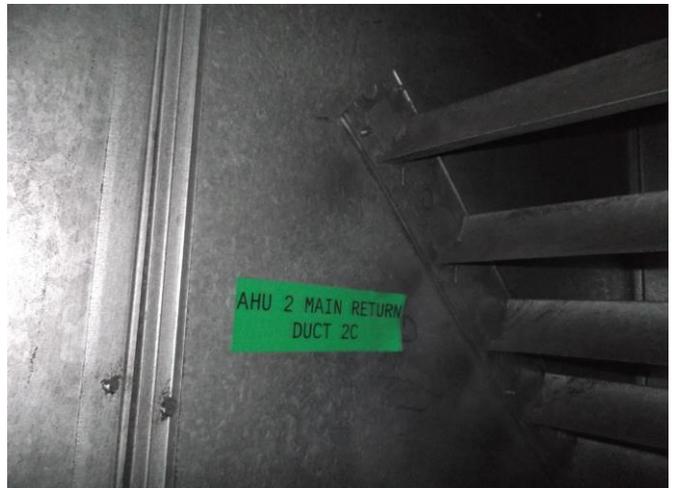
AHU 2 Return air leg 2C

Before cleaning

After cleaning

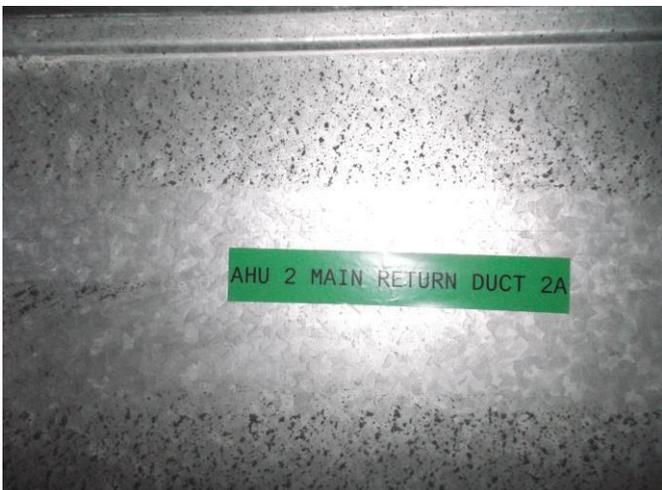
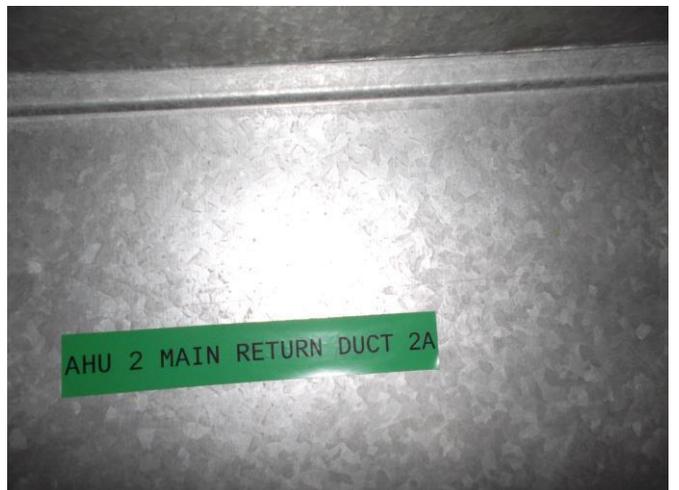
AHU 2 Return air leg 2A

Before cleaning

After cleaning

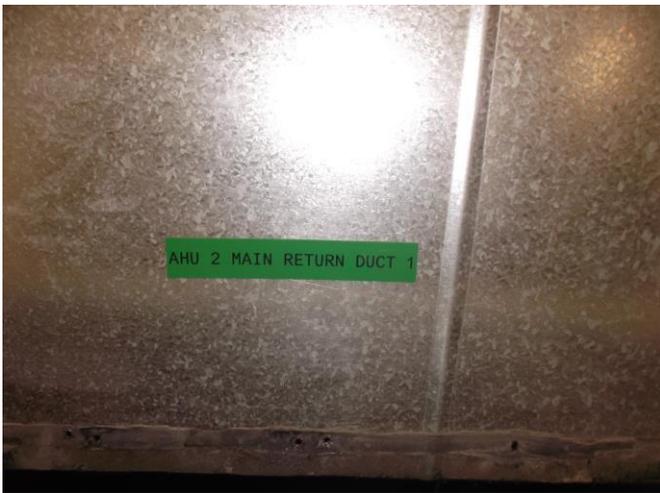
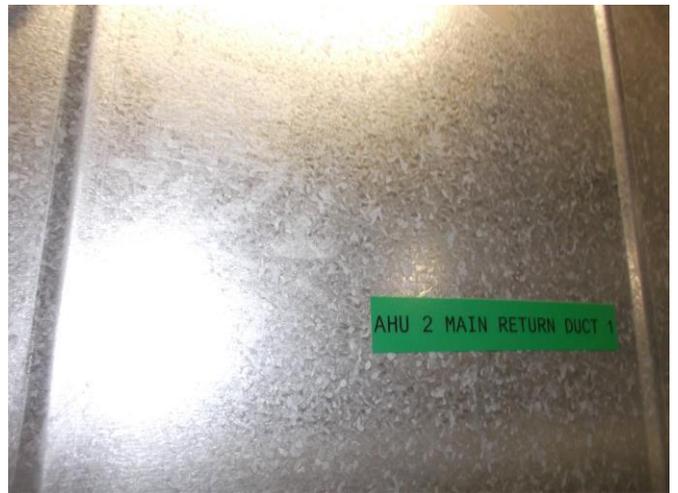
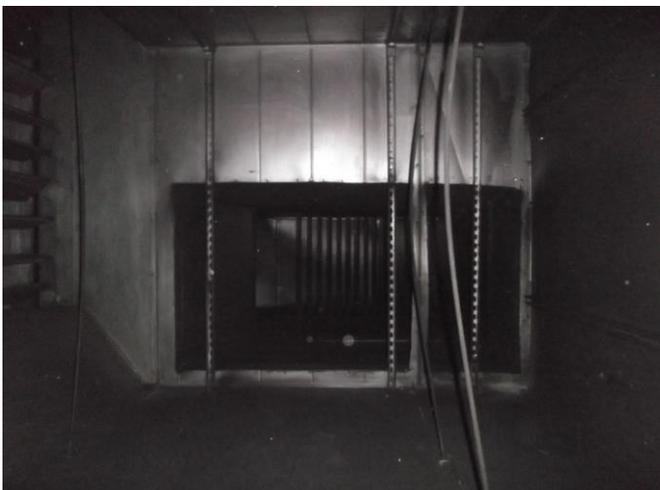
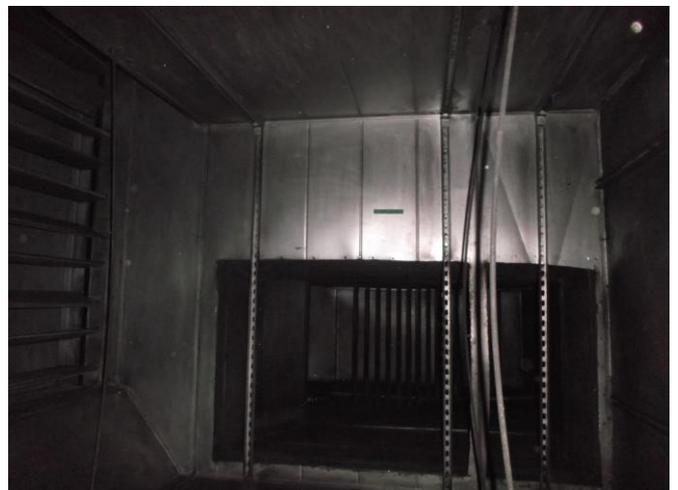
AHU 2 Return air leg 1

Before cleaning

After cleaning

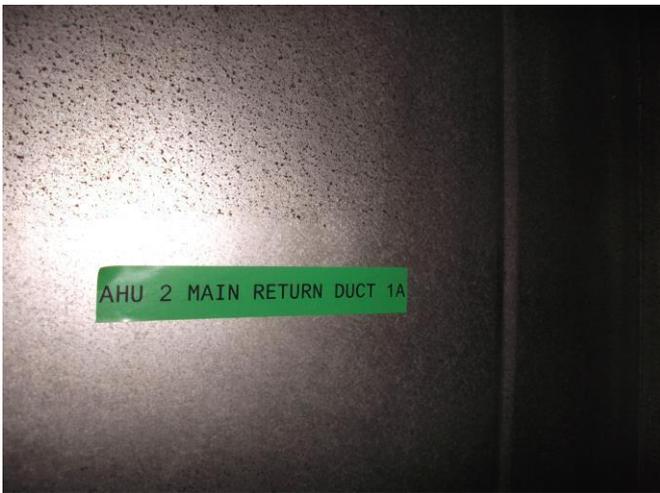
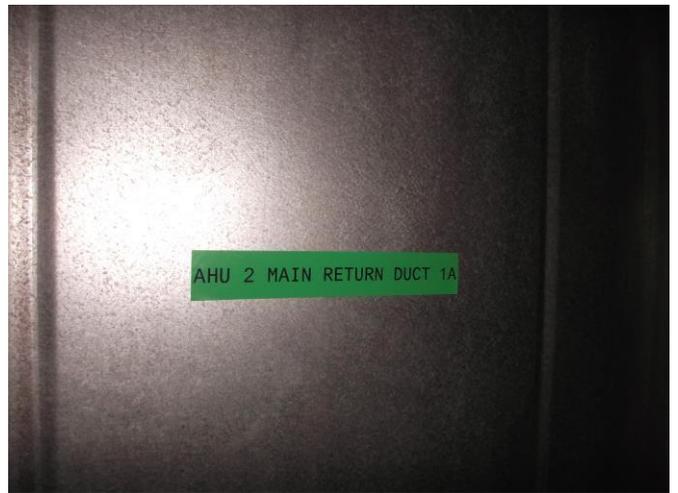
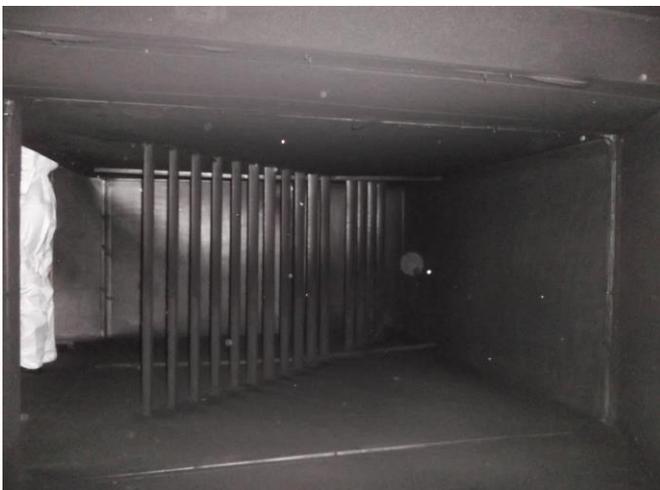
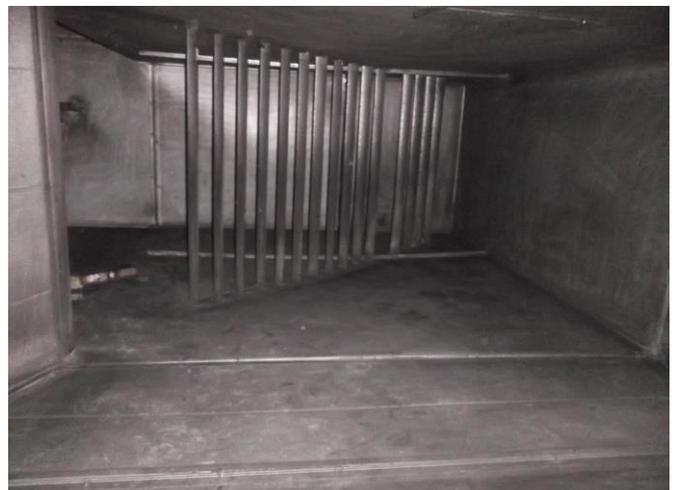
AHU 2 Return air leg 1A

Before cleaning

After cleaning

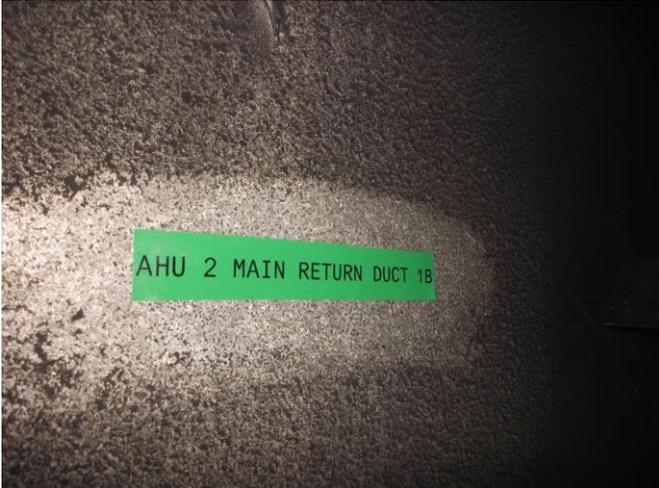
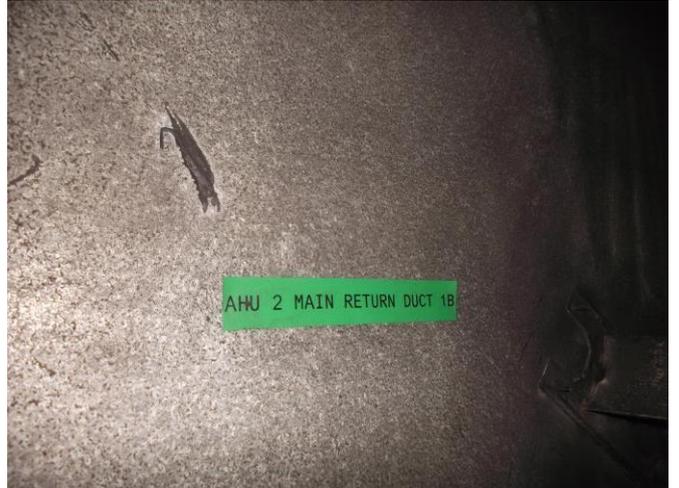
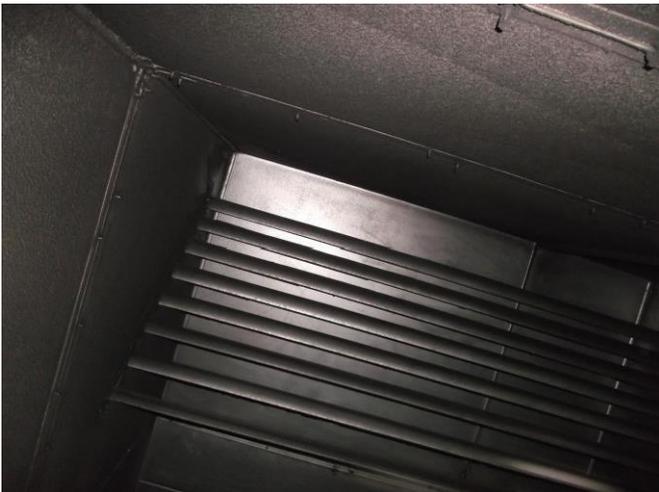
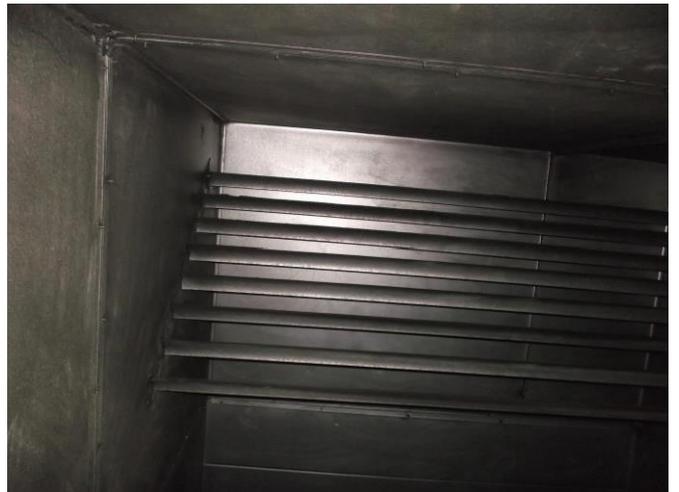
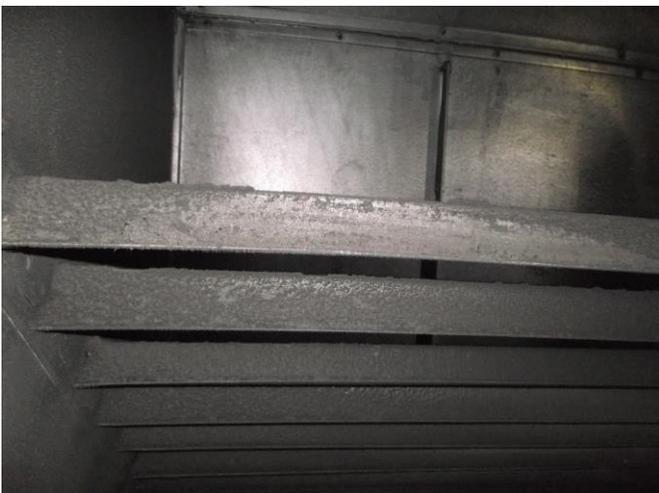
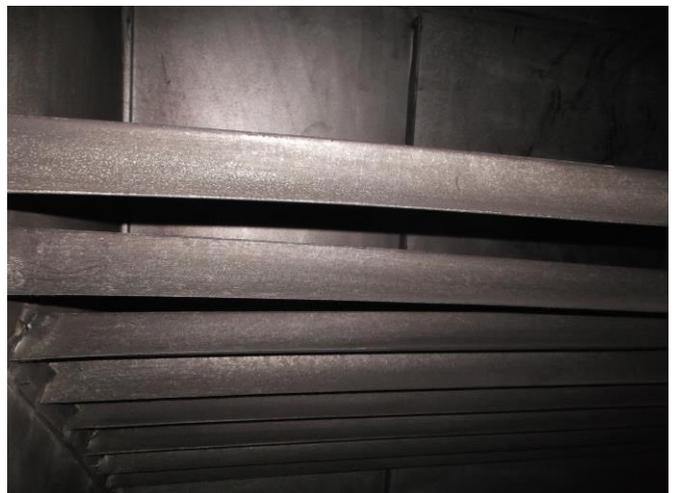
AHU 2 Return air leg 1B

Before cleaning

After cleaning

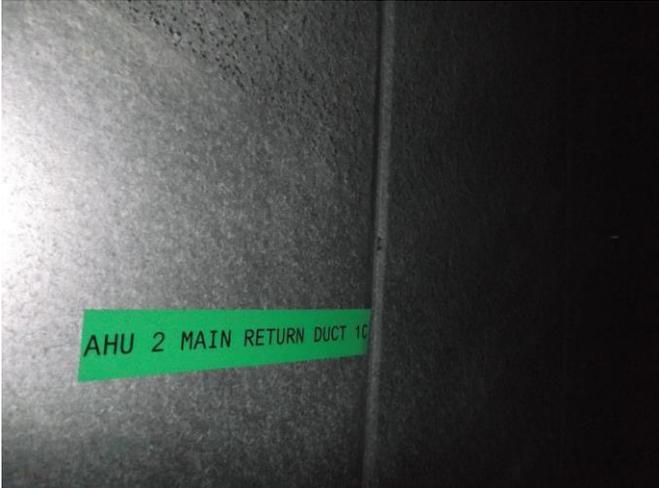
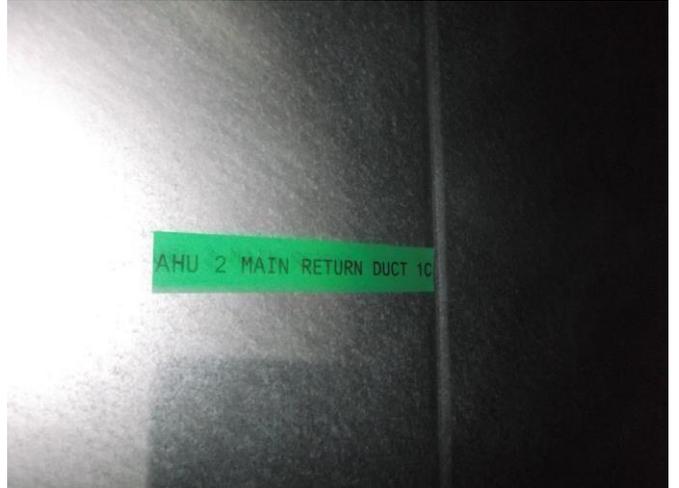
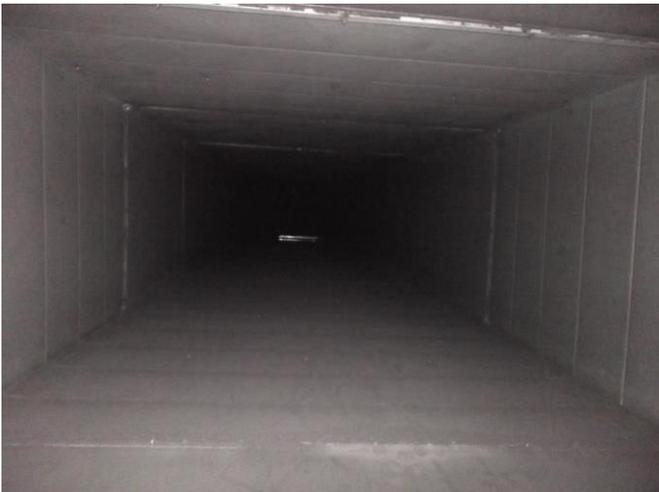
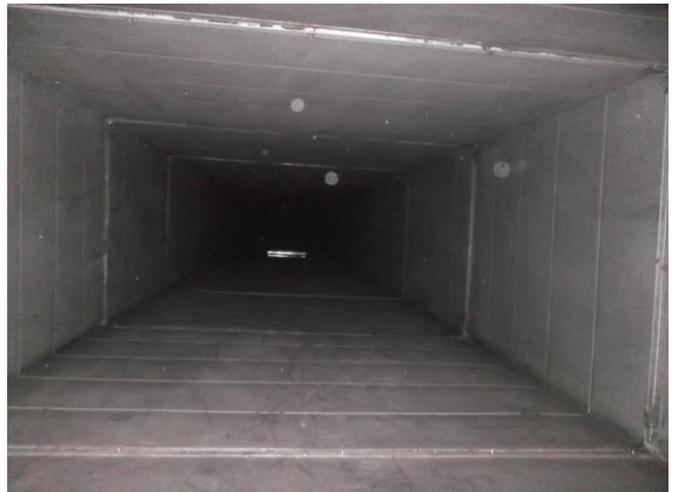
AHU 2 Return air leg 1C

Before cleaning

After cleaning
